### **The LHCb Silicon Tracker: lessons learned (so far)**

# The LHCb Silicon Tracker: lessons learned (so far)

## Abstract

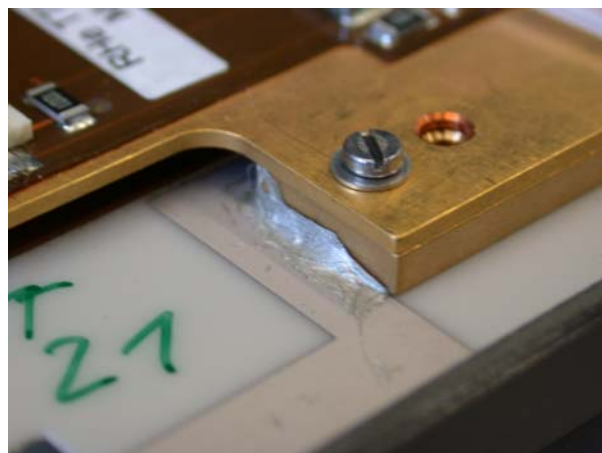
Conductive glue was used to connect the grounding of the TT readout hybrid to the cooling block of the sensor module and for the connection of the biasing voltage on the back side of each silicon sensor. While initial testing showed a good connection, older prototypes suffered from high glue resistances. The reason is due to the inability of the silver glue to stop the oxidization for the underlying aluminium [5]. In addition the grounding of the readout hybrid suffered from thermal cycling (Fig. 2). It was therefore decided to change the connection procedure for these locations. The grounding of the readout hybrids was changed to a screwed solder lug. As no soldering is possible on the back side of a silicon sensor, the bias lines of the Kapton supply cables were bonded to the sensor followed by a glob-top seal to protect the bond wires.

Figure 2: Breakup of silver glue after thermal cycling

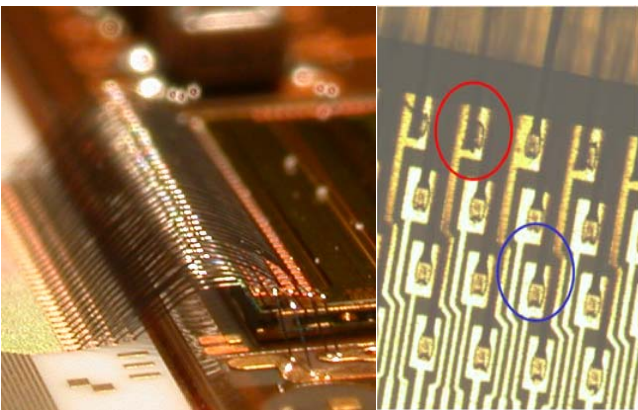
A problem that was discovered very recently concerns the wire bonds at the inputs of the Beetle front-end chips. As shown in Fig. 3, these are executed in four bond-rows to match the four-fold staggered input pads of the Beetle. A few weeks after the installation of the detector modules in the experiment it was found on six out of the 280 installed readout hybrids that a significant number of bonds in the inner-most of these bond rows were broken. Nothing similar had ever been observed in the extensive burn-in tests that each module had to pass during its construction and that were designed to reproduce conditions in the experiment as closely as possible. As of now, we have no explanation for this effect, investigations are ongoing.

Figure 3: 4-fold staggered bonding (left) and comparison of good vs. bad bond connections (right)

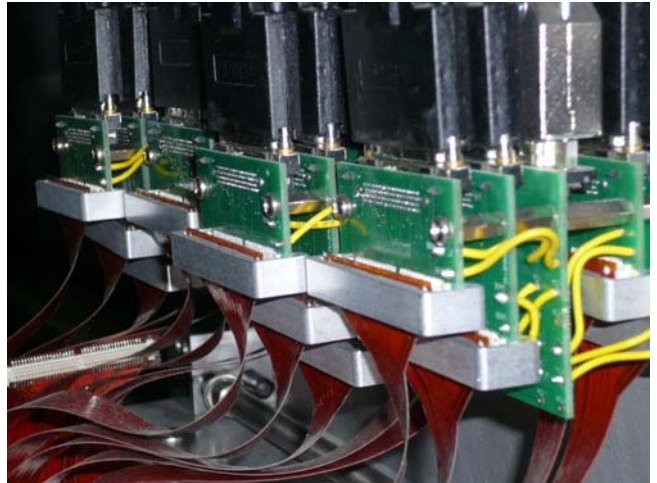
Each readout hybrid requires a single cable connection only, where all necessary supplies and signals are provided. An 80-pin high-density connector was chosen which connects on the Beetle readout hybrid inside the cold volume and to small patch panels outside. Due to the mechanical layout, the inner ends of the cables are guided by small gaps in the main cooling plate. Therefore no torque applies to this mating interface. As space is very limited on the outside between the feedthrough and the patchpanels, the cables had to be bent in tight radii to be mated to the patch panels. The resulting torque led in several cases to unreliable electrical connection between mated high-density connectors. To ensure a mechanical fix of this mating, milled aluminium clamps were

designed which could be applied to the patch panel stack and improved the connection (Fig. 5).

Figure 4: machined aluminium clamps for securing the high-density connectors

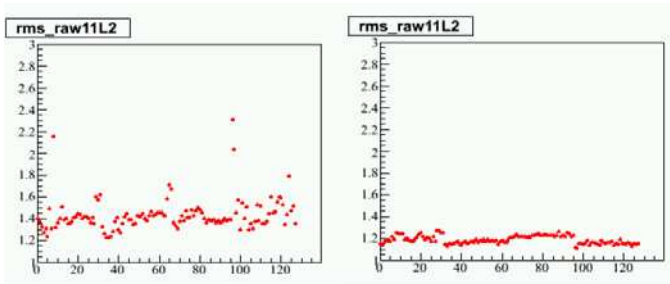
In early laboratory tests, a non-flat noise distribution within a analogue readout frame was discovered. As this distribution was persistent even without any attached readout chip, it was traced back to have its origin inside the Digitizer Board itself.

Figure 5: Comparison of raw noise without filter (left) and with filter (right)

In addition to the sampling rate, any ADC has a specified analogue bandwidth. Usually, this bandwidth exceeds the sampling rate to enable ‘undersampling’, i.e. to digitize a signal with a frequency larger than the sampling rate. To limit the amount of noise at the input of an ADC, a lowpass filter with a properly dimensioned cutoff frequency has to be used. While an early datasheet of the used ADC cited an analogue bandwidth of 100 MHz [6], an updated version listed a bandwidth of 1000 MHz [7]. Tests have shown that a 70 Mhz lowpass, which could be easily added to the existing layout, was sufficient to restore the required flat noise distribution (Fig. 6). This lowpass filter was fitted to all Digitizer Boards prior to installation in the detector.

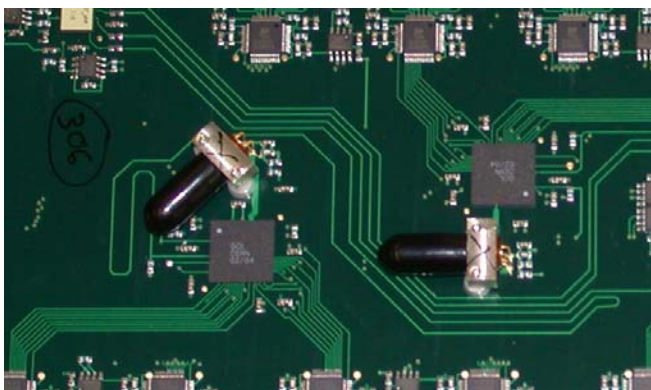
Figure 6: VCSEL diodes with receptacle next to GOL serializer

During reception tests of the production Digitizer Boards, 30 % of the VCSEL diodes were determined to be outside of the optical power specifications. Tests performed by the vendor confirmed a misalignment of the VCSEL diodes inside the metal receptacle. This problem was traced to the soldering procedure of the diodes, which were wave soldered. As the diodes were already fixed to the board via their screws, a large amount of heat was transferred through them into the receptacle which led to the weakening of the glue holding the

diode in alignment. As the preproduction boards were hand-soldered, this problem did not show up during the first batch of boards. A repair of these diodes was not possible and therefore all boards had to be screened and the defective diodes were individually replaced.

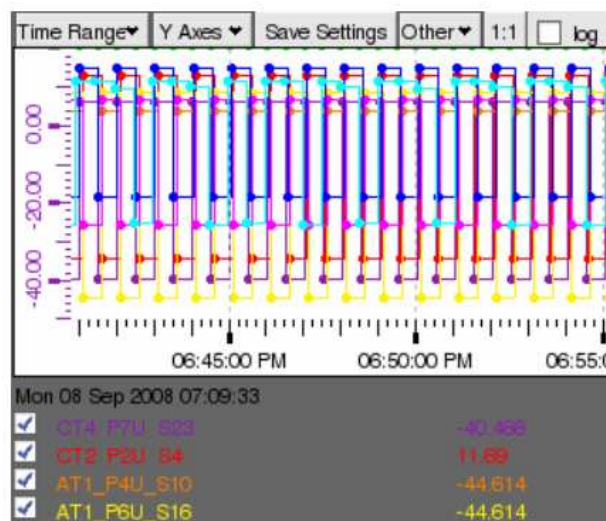
Each Beetle readout hybrid features a PT1000 resistive thermometer, which can be read out by its associated Digitizer Board. This is done via a DCUF slow control ADC [9]. After installation of the Service Boxes in the detector, all ADC readouts showed an oscillating odd-even behaviour (Fig. 8).

Figure 7: oscillating values from the DCUF slow control ADC

The source of this behaviour was determined to be an overvoltage condition on one of the other ADC input channels. An incorrectly dimensioned resistive divider resulted in an input voltage of 3.8 V, which is beyond specifications for a 2.5 V powered ADC. Once this resistive divider was corrected the DCUF readout worked as designed. The change of dividers has only been done for some Digitizer Boards corresponding to selected locations in the detector as this problem was understood only very late in the commissioning process. As these are non-critical readings, the dividers will be changed over time during normal maintenance and board replacements.
