Influence of the type of post and core on in vitro marginal continuity, fracture resistance, and fracture mode of Lithia disilicate-based all-ceramic crowns

Forberger, N; Göhring, T N (2008). Influence of the type of post and core on in vitro marginal continuity, fracture resistance, and fracture mode of Lithia disilicate-based all-ceramic crowns. *Journal of Prosthetic Dentistry*, 100(4):264-273.

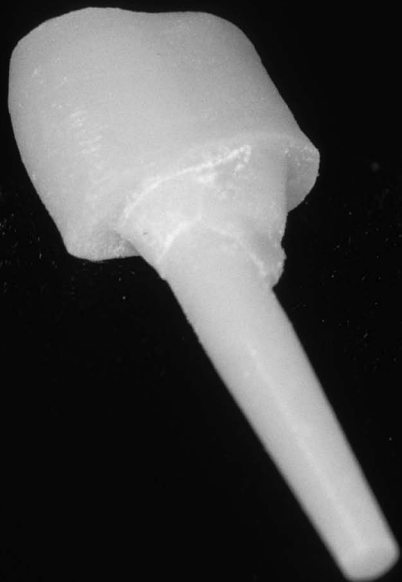
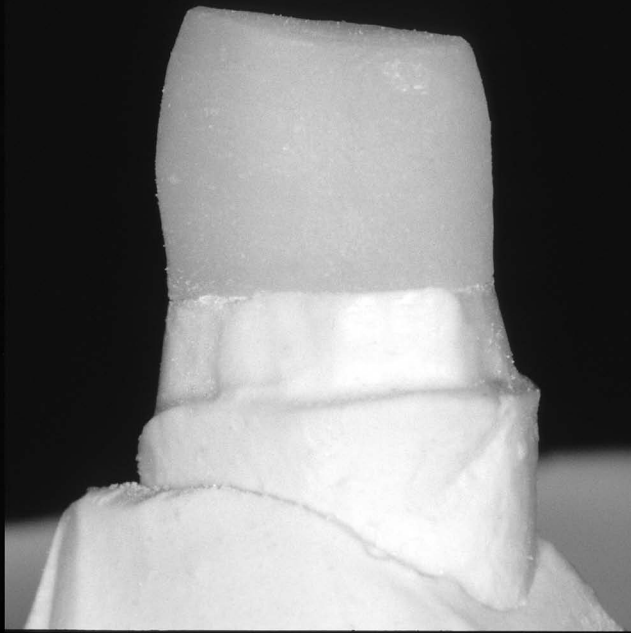
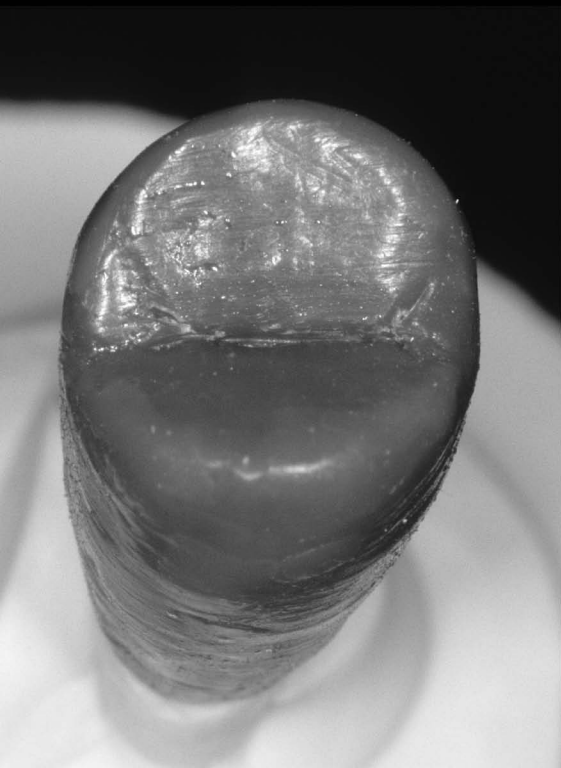
Fig. 1. A, Zirconia ceramic endodontic post with heat-pressed ceramic core. All preparations had vertical height of 5 mm (2 mm of coronal dentin, 3 mm of core height). B, Standardized wax crown pattern. C, Heat-pressed lithia disilicate-based ceramic crowns.

In the ZRO-POST group, size 2 (cervical diameter 1.7 mm; size 1 was not available at the time the study was conducted) cylindroconical zirconia ceramic posts (CosmoPost, lot F34596; Ivoclar Vivadent) were placed. To accommodate the posts, the root canals were enlarged from the sectioned root surfaces to a depth of 10 mm using the manufacturer's recommended drills in a slow-speed contra-angle handpiece. The 20.6-mm-long posts were placed in the post spaces and impressions were made (President Plus light body; Coltène/Whaledent AG, Altstätten, Switzerland). Casts were produced (Fujirock; GC Corp, Tokyo, Japan), and the posts were reduced to a length of 15 mm with a diamond rotary cutting instrument. Wax cores were formed around the posts (Schuler-Dental; Ulm, Germany). The zirconia ceramic posts with wax cores were embedded (Empress 2 Speed, lot D98022, F98047 and liquid lot D98023; Ivoclar Vivadent). After warming for half an hour at 850°C, liquid glass ceramic (Experimental press, lot HAT300/2366; Ivoclar Vivadent) was pressed into the lost-wax space at 920°C and 5 bar. After 60 minutes of cooling to room temperature, the posts and cores were removed and airborne-particle abraded using aluminum oxide (50 µm; Kaladent, Zürich, Switzerland) at 2 bar pressure. The posts were cleaned with steam and filled with luting resin (Variolink; Ivoclar Vivadent), and dentin bonding procedures were performed as described for group FRC-POST (Fig. 1, A).
