# Prevention of outburst floods from periglacial lakes at Grubengletscher, Valais, Swiss Alps

WILFRIED HAEBERLI,<sup>1</sup> ANDREAS KÄÄB,<sup>1</sup> DANIEL VONDER MÜHLL,<sup>2</sup> PHILIP TEYSSEIRE<sup>3</sup>

**ABSTRACT.** Flood and debris-flow hazards at Grubengletscher near Saas Balen in the Saas Valley, Valais, Swiss Alps, result from the formation and growth of several lakes at the glacier margin and within the surrounding permafrost. In order to prevent damage related to such hazards, systematic investigations were carried out and practical measures taken. The evolution of the polythermal glacier, the creeping permafrost within the large adjacent rock glacier and the development of the various periglacial lakes were monitored and documented for the last 25 years by photogrammetric analysis of annually flown high-resolution aerial photographs. Seismic refraction, d.c. resistivity and gravimetry soundings were performed together with hydrological tracer experiments to determine the structure and stability of a moraine dam at a proglacial lake. The results indicate a maximum moraine thickness of > 100 m; extremely high porosity and even ground caverns near the surface may h

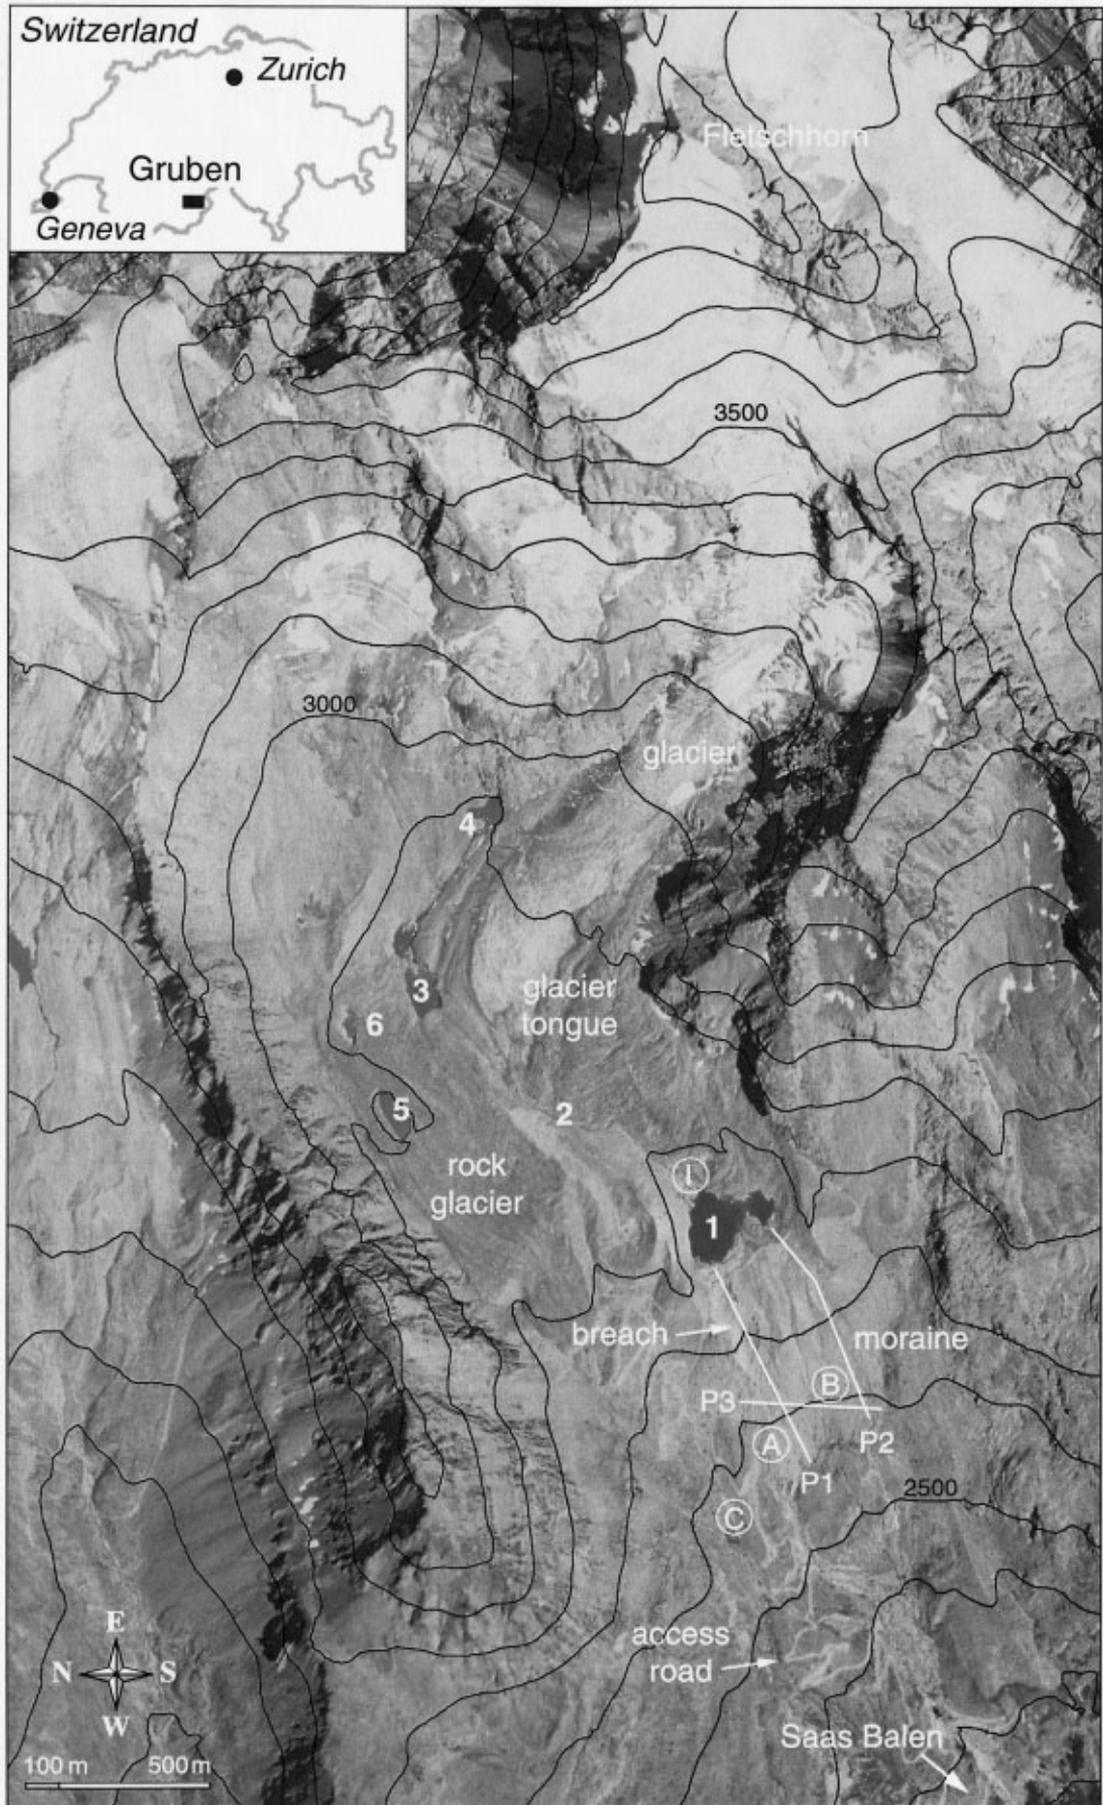
Fig. 1. Situation (Switzerland) and orthophoto map of the Gruben cirque between the Fletschhorn (3993 m a.s.l.) and Saas Balen (not visible). Numbers 1–6 refer to the periglacial lakes, letters A–C to important springs related to hydrological investigations, and I to the injection point for tracer experiments. Lines  $P_1$ ,  $P_2$  and  $P_3$  are seismic refraction profiles. Geoelectrical d.c. resistivity soundings were taken along the seismic lines  $P_1$  and  $P_2$ ; gravimetric measurements were made along  $P_1$  and  $P_2$  and also perpendicular to these lines along the contour lines 2650 and 2770 m a.s.l. Air photos taken by Federal Office of Cadastral Surveys, 30 August 1991, flying height 8000 m a.s.l.

The region under study lies within a glacial cirque in which the tongues of Grubengletscher and of the Gruben rock glacier lie side by side (Fig. 1). Several lakes formed within this complex combination of polythermal glacier ice, thick morainic deposits and discontinuous permafrost. For historical reasons, the numbering of the lakes starts with the proglacial Lake No. 1, then proceeds up-glacier to the ice-marginal Lakes No. 2, 3 and 4, and finally includes Lakes No. 5 and 6 in dead ice deposited within periglacial permafrost. Following two outbursts of ice-dammed Lake No. 3 in 1968 and 1970, an access road was constructed to enable flood prevention work and corresponding site investigations. The same road together with accumulated local knowledge also greatly facilitated projects of predominantly scientific interest (Barsch and others, 1979; Haerberli and others, 1979; Haerberli and Fisch, 1984; Haerberli, 1985; Käab and others, 1997).

The topographic depression at the right glacier margin contains the ice-dammed Lakes No. 4, 3 and 2 (Fig. 1), the development and safety of which are strongly affected by changes in mass and geometry of the glacier.

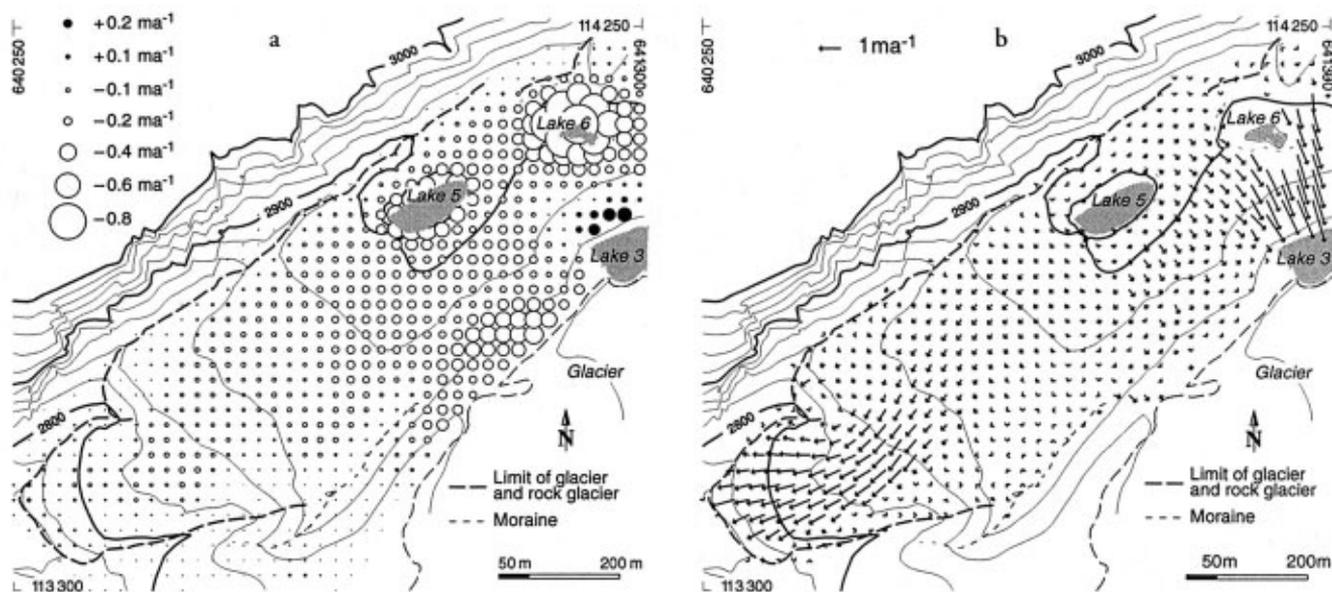
Fig. 2. Topography, surface elevation change and surface displacements on the Gruben rock glacier. (a) Topography of 1991 and changes in surface elevation during 1970–95 indicating different subsidence rates in the periglacial part (lower left) and the glacier-affected part containing massive remains of dead ice (upper right). (b) Surface displacements on the Gruben rock glacier during 1970–95 indicating different creep regimes of the periglacial part (lower left) and the glacier-affected part (upper right). The velocity field and the changes in surface elevation allow for an estimate of recent glacial impacts and related dead-ice occurrences on the rock glacier.

During the mid-1960s, crevasses formed at the upper margin of dead-ice occurrences within the creeping permafrost area (cf. Fig. 2). Two corresponding depressions progressively enlarged, forming the thermokarst Lakes No. 6 and 5.

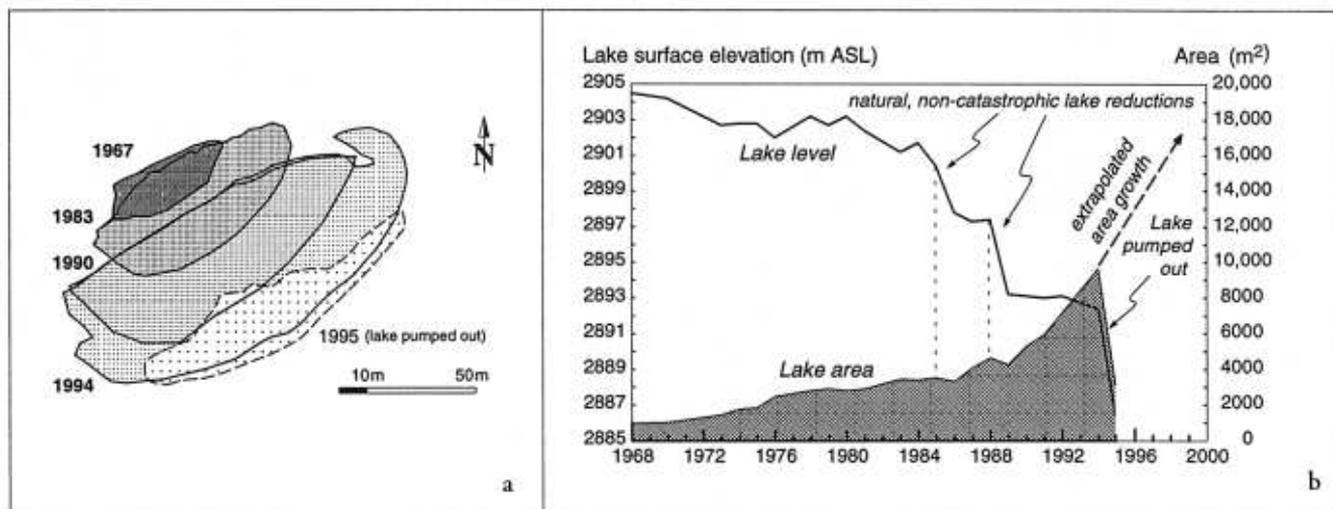
Fig. 3. Growth of thermokarst Lake No. 5. (a) Planimetric representation of the lake outline in selected years of the time period 1967–95 (note asymmetric lake growth towards the massive ground ice in the south; the sudden displacement of the northern lake shore is a consequence of the lake-level lowering in 1984). (b) Lake level and area over the period 1968–95. Lake level smoothly dropped some meters in 1985 and 1988; assessment of future lake growth suggested an area of about 20 000 m<sup>2</sup> or a volume of 100 000 m<sup>3</sup> in the year 2000 (dashed line with arrow). In 1995, the lake was pumped out due to its increasing hazard potential.

The surface of Lake No. 5 grew at an accelerating rate and asymmetrically towards the south, exposing there an increasingly high ice front. In 1994, the lake reached an area of  $10\,000 \text{ m}^2$  and a volume of some  $50\,000 \text{ m}^3$  (Fig. 3). During the summer, the lake surface was more or less free of ice, and the water warmed to temperatures of about  $2^\circ\text{C}$  under the influence of solar radiation and high air temperatures. As shown by strong undercutting of the ice front and drifting of small icebergs away from it, the density increase due to warming triggered a process of thermal convection: warmer and denser surface water sinks to the lake bottom, flows towards the ice front, cools by ice melting and undercutting the ice front, thereby reducing its density, and rises again to the lake surface where it flows away from the ice front and warms up (Fig. 4). Such convection is strengthened by a positive feedback, in that melting of ice leads to a larger surface area of the lake, increased energy input and more melting, etc. This positive feedback together with the existence of massive ground ice represents the main cause for the accelerating lake growth.

During the early 1990s, the last years of its existence, Lake No. 5 grew annually by about  $1500 \text{ m}^2$  in surface area and  $7500 \text{ m}^3$  in volume. On two occasions in the 1980s, the lake level smoothly dropped by several meters without leaving

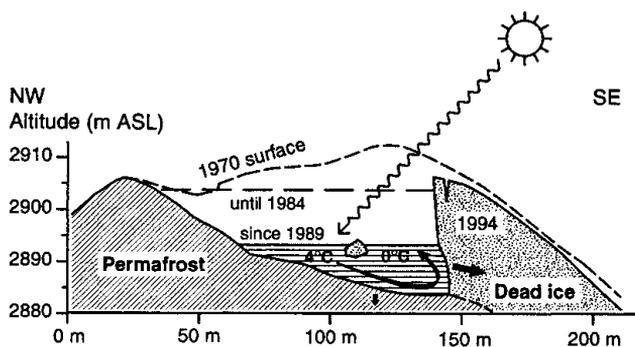
Fig. 4. Schematic representation of energy input by solar radiation, convective heat transport to the damming front of buried massive ice, subsequent ice melt and water cooling of the lake water leading to a positive feedback which drives the non-linear growth of thermokarst Lake No. 5. After drainage of the lake, strong undercutting and vertical pear-like convexities of about 1 m height were found in the exposed ice front, presumably related to local thermic convection cells.

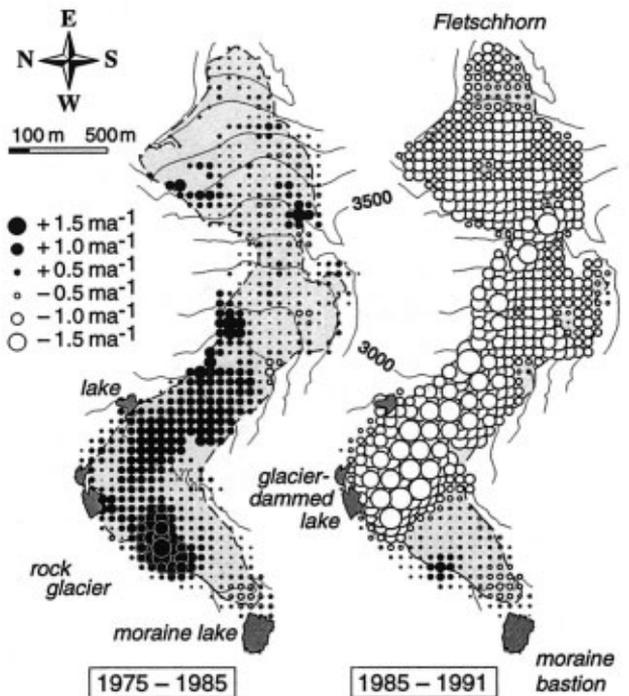
Fig. 6. Spatial pattern of mean annual changes in surface elevation of Grubengletscher during the time intervals 1975–85 (left) and 1985–91 (right). The results were derived from regularly spaced photogrammetrically measured digital terrain models (DTMs) (50 m grid) of 1975, 1985 and 1991. Note the strong increase in surface elevation affecting the lower part of the glacier tongue and indicating an advance between 1975 and 1985 followed by decrease in ice thickness from 1985 to 1991.

Lake No. 2 was situated at the right margin of the heavily debris-covered part of the glacier tongue (Fig. 1). Its area was continuously reduced by the growing glacier (cf. Fig. 6) from some 2000 m<sup>2</sup> in 1975 to its complete disappearance in 1981.

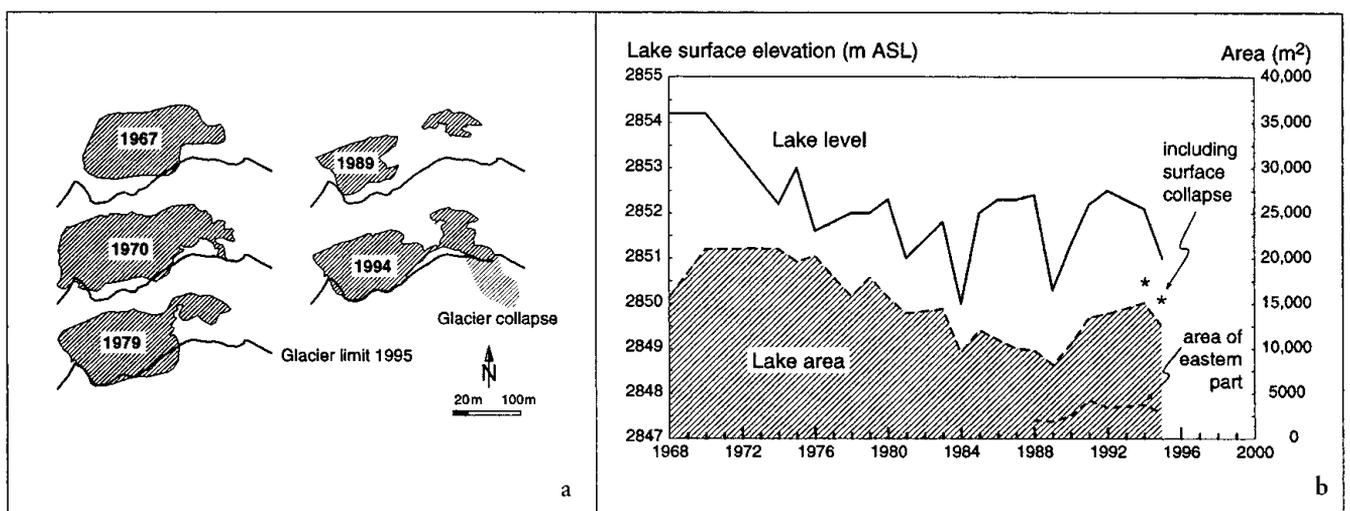
Fig. 5. Evolution of ice-dammed Lake No. 3 during the time period 1968–95. (a) Planimetric representation of the lake outline at selected times of photography, 1967–94. (b) Lake level and area as a function of time. Note that lake level is varying over time. The presented values only reflect the situation at the time of aerial photography in the fall.

flown annual air photos. Between 1976 and 1989, the slightly advancing glacier had reduced the area of the lake surface (Fig. 5). More recently, glacier shrinkage enabled renewed increase in lake surface area by melting and undercutting of the calving ice front (cf. Haeberli and Röthlisberger, 1976; Iken, 1977). In 1996, the lake surface area had reached 18 000 m<sup>2</sup>. A collapse structure in the ice, visible on air photos since 1994, indicated that the lake water had begun to melt a large cavity underneath the glacier, probably in connection with water from Lake No. 4 flowing over morainic material and entering the eastern part of Lake No. 3. The total lake volume could, therefore, only roughly be estimated at about 100 000 m<sup>3</sup> (for 1996). The lake had not always been completely full during the air-photo flights in the fall, a fact which must be taken into account when interpreting the evolution of the photogrammetrically mapped lake surface.

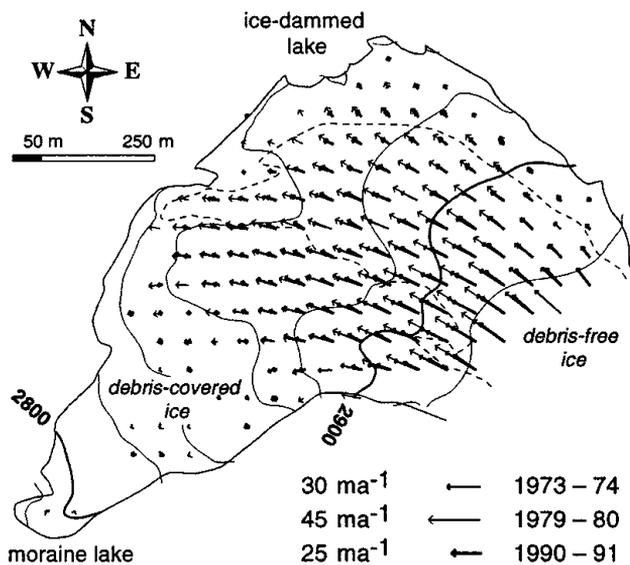
Fig. 7. Field of mean annual velocities on the tongue of Grubengletscher during the time intervals fall 1973–fall 1974, fall 1979–fall 1980 and fall 1991–fall 1992. The average surface velocity dropped drastically between the latter two stages, presumably due to marked changes in subglacial water pressure.

Information from the annually flown low-altitude air photos (Kääb, 2000) showed that the velocity of ice flow on the glacier tongue at Lake No. 3 (Figs 7 and 8) had reached a maximum around 1980 and then dropped by about 50% until 1994. This drastic reduction of flow velocity is only partially correlated with changes in ice thickness (cf. Fig. 8), probably due to changes in the subglacial water pressure. It caused the ice dam at Lake No. 3 to lower after 1985, i.e. 5 years after the velocity maximum in 1980, at a rate of  $-1.5 \text{ m a}^{-1}$  on average with an extreme value of  $-3 \text{ m a}^{-1}$  in 1990. In 1994, the ice surface was lower than in the years of

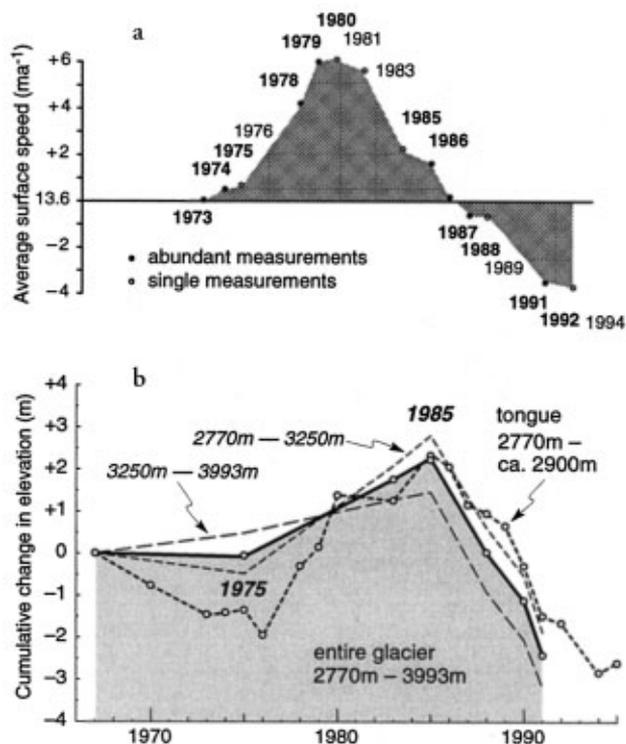
Fig. 8. Change in flow velocity and surface elevation on the tongue of Grubengletscher during the time interval 1973–92. (a) Cumulative changes in mean annual velocity. Bold data points indicate high-precision results from redundant and independent photogrammetric measurements; unfilled ones indicate single measurement procedures. (b) Cumulative changes in average elevation of the entire Grubengletscher (filled area) and its tongue (dotted line), 1967–91 (1967–95 for the tongue). Due to the limited availability of high-altitude aerial photographs covering the entire glacier, DTMs could be collected only in selected years, whereas a DTM of the tongue region could be measured almost every year.

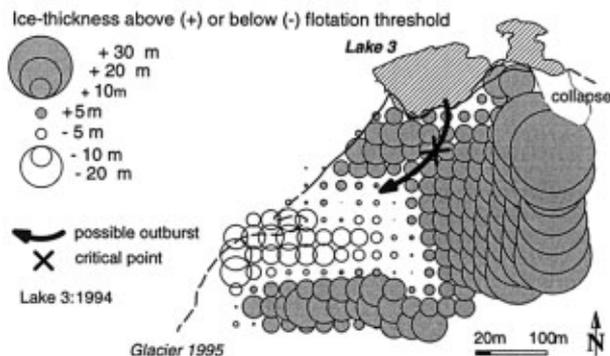
Fig. 9. Safety of ice-dammed Lake No 3 in 1995: ice thickness above flotation threshold was calculated from glacier bed topography determined by radio-echo sounding, photogrammetry-derived ice-surface topography and extrapolated lake level applying the “iceberg model” of Nye (1976).

Ice depth near Lake No. 3 is known from radio-echo soundings and hot-water drillings which were combined with subglacial d.c. resistivity soundings using borehole electrodes (Haeberli and Fisch, 1984). Based on this information and the above-mentioned photogrammetric data, the safety against dam failure was calculated as the excess thickness above the critical flotation threshold (Fig. 9). In the fall of

1995, this safety reached a minimum of 8 m at the thinnest point of the ice dam. By extrapolating the observed subsidence rates ( $-1.5$  to  $-3$  m a<sup>-1</sup>) of the ice surface, a potential

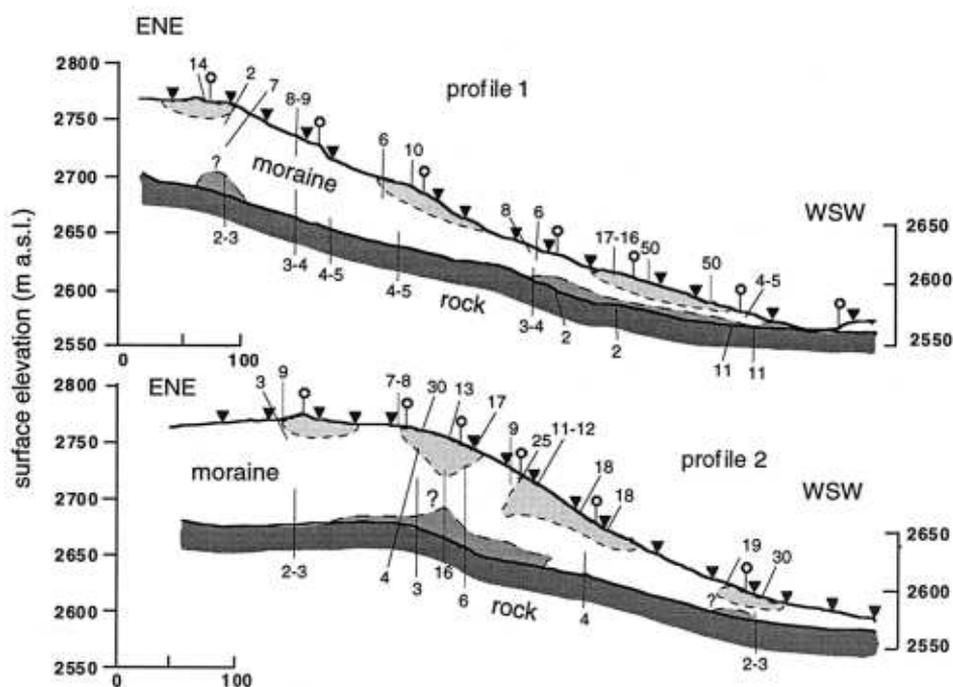
Fig. 10. Two sections through the moraine dam near Lake No. 1 as obtained from seismic refraction and d.c. resistivity soundings. Numbers refer to an index combining the results from the two sounding methods mentioned in the text. The light-dotted area shows loosely compacted layers, the darker-dotted area represents possible occurrences of ground water, and the remaining parts are non-saturated and well-compacted morainic material.

Three seismic refraction profiles and 13 geoelectrical d.c. resistivity soundings were measured in 1993 by GEOTEST Consulting Company (Geotest, unpublished; Figs 1 and 10). Geoelectrical d.c. resistivity of (unfrozen) bedrock was determined to be about  $9 \text{ k}\Omega\text{m}$  at outcrops near the foot of the moraine slope. The internal moraine structure (Fig. 10) was analyzed using characteristic values for seismic velocities and d.c. resistivities usually observed in starting zones of debris flows (Haeberli and others, 1990). In addition, the ratio  $\rho(\Omega\text{m})/V_p(\text{m s}^{-1})$  between the electrical resistivity  $\rho$  and the seismic velocity  $V_p$ , multiplied by a factor  $R$  reflecting the

The seismic refraction soundings indicated bedrock as a marked refractor with P-wave velocities of  $3900\text{--}4900 \text{ m s}^{-1}$  (Fig. 10). Bedrock depth is only a few meters at the foot of the moraine dam but increases continuously towards Lake No. 1 where it reaches 100 m and more. Within the uppermost 5–20 m of the moraine, seismic velocities are  $400\text{--}900 \text{ m s}^{-1}$  and resistivities are 2 to  $>15 \text{ k}\Omega\text{m}$  in places. Deeper morainic layers are characterized by seismic velocities of  $1000\text{--}1700 \text{ m s}^{-1}$  and resistivities of  $2\text{--}8 \text{ k}\Omega\text{m}$ . The highest resistivity values are correlated with very low seismic velocities, indicating large porosity rather than ground ice (which would have high seismic velocities). Particularly loose parts of the moraine therefore occur relatively close to the surface, whereas indications for ground-water-bearing layers are sparse and concentrated at the interface between bedrock and the moraine.

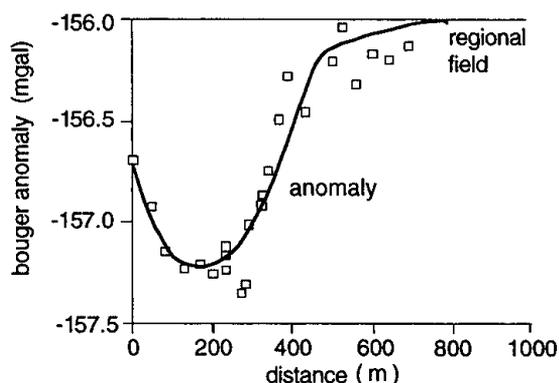
Fig. 11. Regional and residual gravity field of a profile across the moraine dam along profiles  $P_1$  and  $P_2$  in Figure 1. (Lake No. 1 is to the left, and the bottom of the moraine to the right of plot) assuming a constant regional field of  $-156.0$  mgal. The residual anomaly is up to  $-1.2$  mgal.

With total thickness and internal structure of the moraine being known from the seismic and geoelectrical soundings, gravimetry was applied to estimate density and porosity of the morainic material. As the gravity map of Switzerland (Klingelé and Olivier, 1980) gives small gradients in the investigated area, the interpretation of the long profiles is based on the assumption that the regional gravity field is horizontal ( $-156.0 \text{ mgal}$ ). The resulting Bouguer anomaly for the moraine area is  $-1.2 \text{ mgal}$  (Fig. 11), and the corresponding density contrast about  $0.3 \text{ Mg m}^{-3}$ . Bedrock density was measured, using local samples, as  $2.76 \text{ Mg m}^{-3}$ , giving an average density ( $\rho$ ) of the moraine of roughly  $2.4\text{--}2.5 \text{ Mg m}^{-3}$ , and a mean porosity ( $n$ ) of 11% in air/rock mixtures and of 17% in water/rock mixtures. Such a low

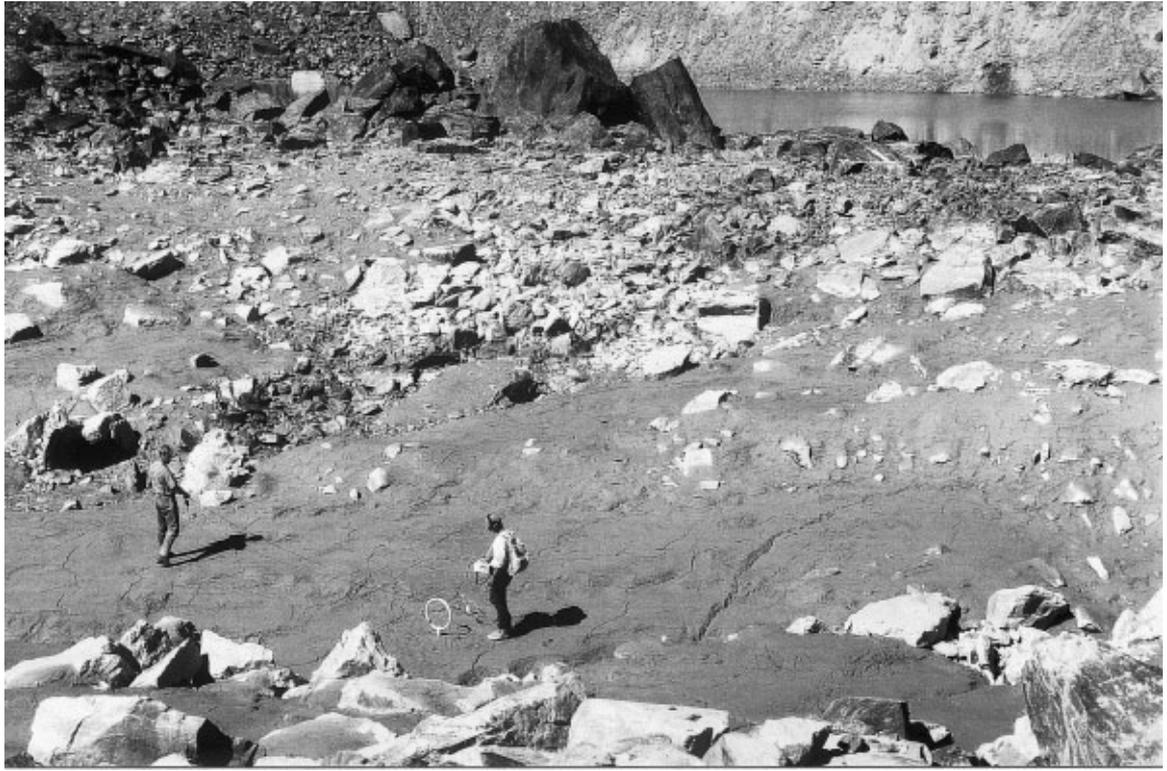
Fig. 12. Silty bottom of empty southern part of Lake No. 1; the view is towards the threshold between the southern and northern lake parts. Note small channels eroded to the gravelly bed (photo W. Haeblerli, September 1992).

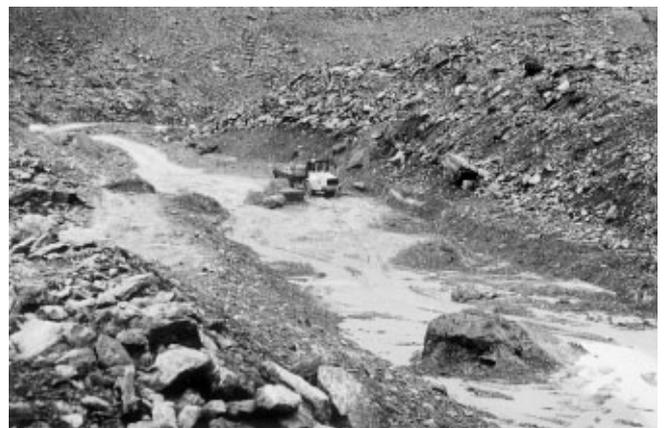
Fig. 13. Excavation of a drainage channel for ice-marginal Lake No. 3 (photo A. Kääb, 1995).

The growing risk of large water volumes bursting out from Lake No. 3 was eliminated by lowering the lake level and reducing the lake surface area and volume. This was accomplished in summer 1996 by opening an approximately 2 m deep channel along the glacier margin and creating a periglacial outlet through the contact zone between the glacier and the rock glacier (Fig. 13). Removal of large, thermally insulating blocks of rock from the surface, and the

effect of water running through the excavated channel may melt remains of frozen ground and enable continuous natural erosion of the channel to increasing depth, thereby further lowering lake level and volume. The excavated material was deposited in the lake and reduced its area and volume to a fraction of its original values.

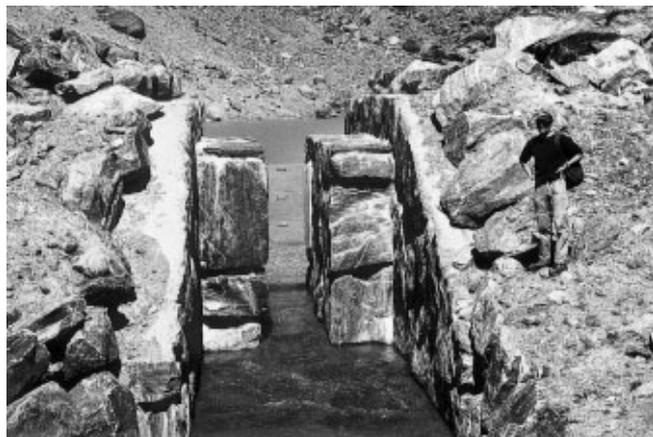
Fig. 14. New (lowered) flood-release (overflow) structure with regulating gates at proglacial Lake No. 1 (photo W. Haerberli, July 2000).

The overflow level of Lake No. 1 was lowered by about 2 m in summer 1996. The discharge capacity of the narrow concrete spillway through the existing dam (Fig. 14) consisting of coarse blocks is limited with regulating gates to  $3 \text{ m}^3 \text{ s}^{-1}$  in its lower part. This enables controlled outflow during events of suddenly rising lake level, and enlarges the retention capacity of the lake basin by about  $50\,000 \text{ m}^3$ . Inflow to, and outflow from, the outlet structure as well as the geometry of the foreland on the water side were adjusted by earthwork. During the fall of the same year, a grout curtain was created by injecting concrete through 10 m deep boreholes with a 1 m spacing. As a result, percolation distances underneath the dam consisting of coarse blocks became longer, reducing the hydraulic gradient and the potential for piping underneath the outlet structure. Ground-water levels are being observed on both sides of the grout curtain. The continuation of direct observations and special air-photo flights form an integral part of the hazard-mitigation scheme and should enable appropriate steps to be taken in time and according to the changes documented in the future.
