## **Prevention of outburst floods from periglacial lakes at Grubengletscher, Valais, Swiss Alps**

Haeberli, Wilfried; Kääb, Andreas; Vonder Mühlh, Daniel; Teyssseire, Philip (2001). Prevention of outburst floods from periglacial lakes at Grubengletscher, Valais, Swiss Alps. *Journal of Glaciology*, 47(156):111-122.

# Prevention of outburst floods from periglacial lakes at Grubengletscher, Valais, Swiss Alps

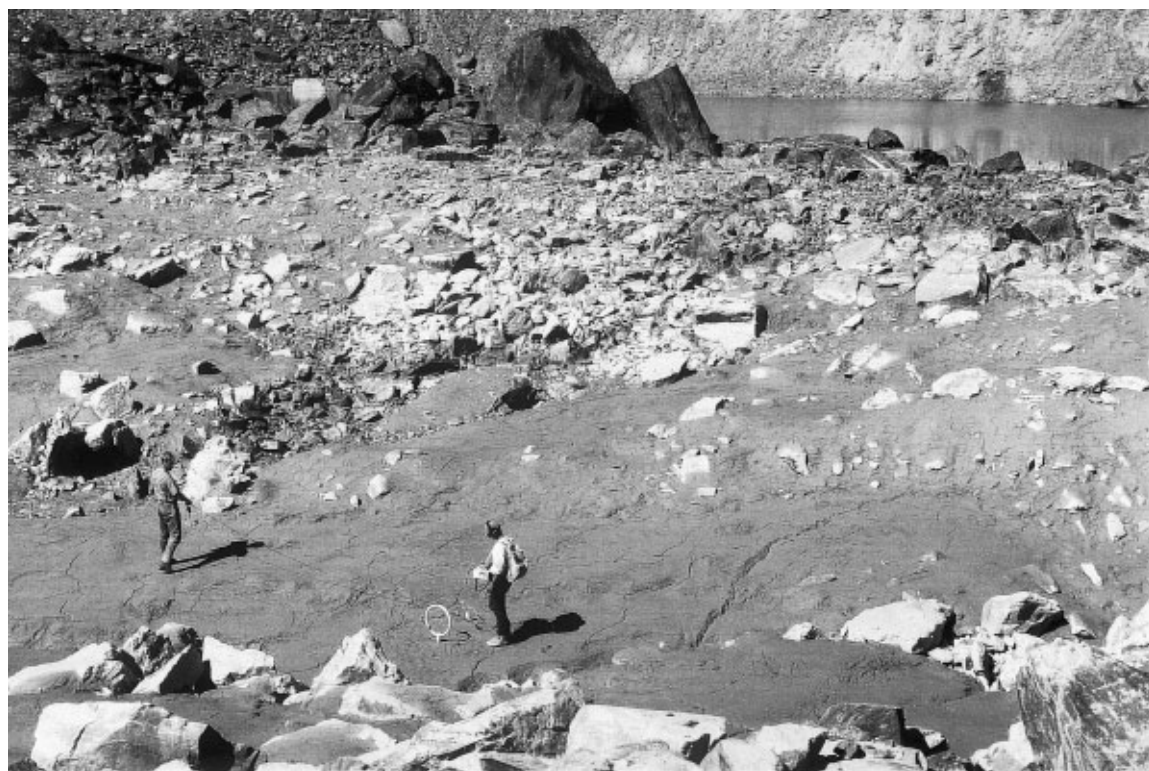
Fig. 12. Silty bottom of empty southern part of Lake No. 1; the view is towards the threshold between the southern and northern lake parts. Note small channels eroded to the gravelly bed (photo W. Haerberli, September 1992).

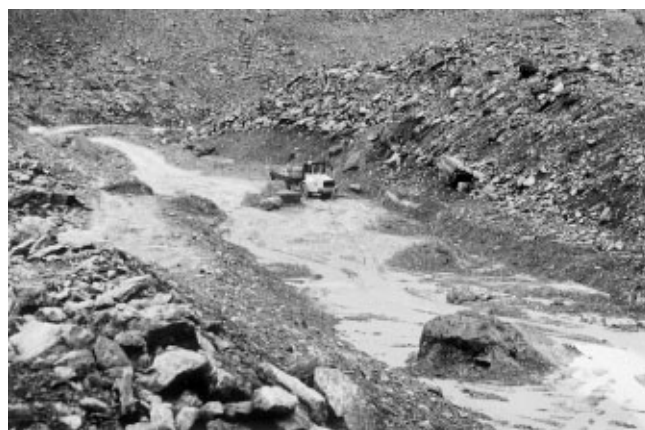
Fig. 13. Excavation of a drainage channel for ice-marginal Lake No. 3 (photo A. Kääb, 1995).

The growing risk of large water volumes bursting out from Lake No. 3 was eliminated by lowering the lake level and reducing the lake surface area and volume. This was accomplished in summer 1996 by opening an approximately 2 m deep channel along the glacier margin and creating a periglacial outlet through the contact zone between the glacier and the rock glacier (Fig. 13). Removal of large, thermally insulating blocks of rock from the surface, and the

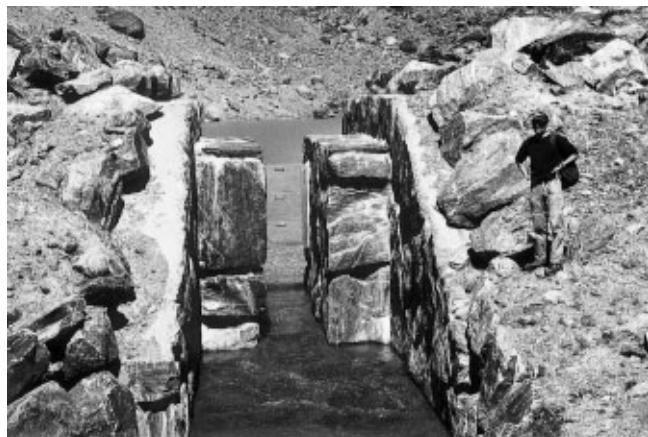
Fig. 14. New (lowered) flood-release (overflow) structure with regulating gates at proglacial Lake No. 1 (photo W. Haerberli, July 2000).
