The influence of aluminium, steel and polyurethane shoeing systems and of the unshod hoof on the injury risk of a horse kick: an ex vivo experimental study

Dissertation

**The influence of aluminium, steel and polyurethane shoeing systems and of the unshod
hoof on the injury risk of a horse kick – An ex vivo experimental study**

Inaugural-Dissertation

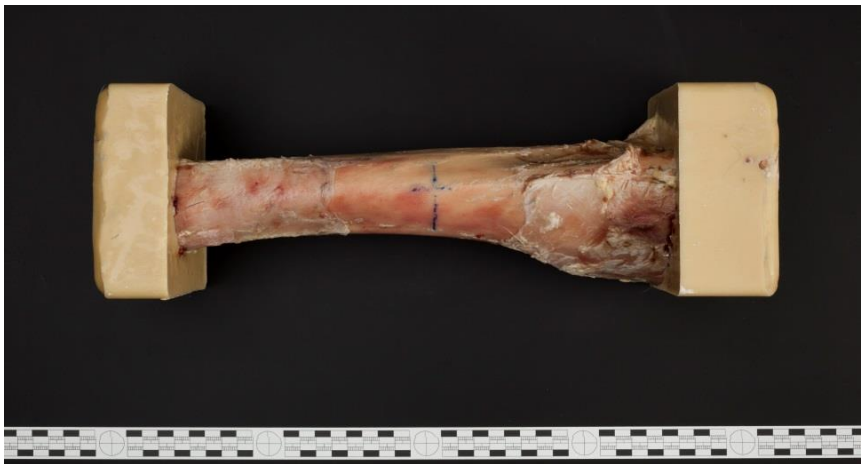
Fig. 1: Dissected left tibia with the proximal and distal ends embedded in polyurethane. The blue cross indicates where the impactor was intended to impact the bone.

on both ends to a final length of 38 cm. The proximal and distal ends of the specimens were casted in polyurethane^a up to 1cm above the metaphysis (Figure 1). The bones were wrapped in a cloth soaked in 0.9 % saline solution and placed in plastic bags in order to prevent drying. The bones used in this study had been stored at -20 °C for 15 years (n = 4), 11 years (n = 56) or two month (n = 4). Testing was done at room temperature.

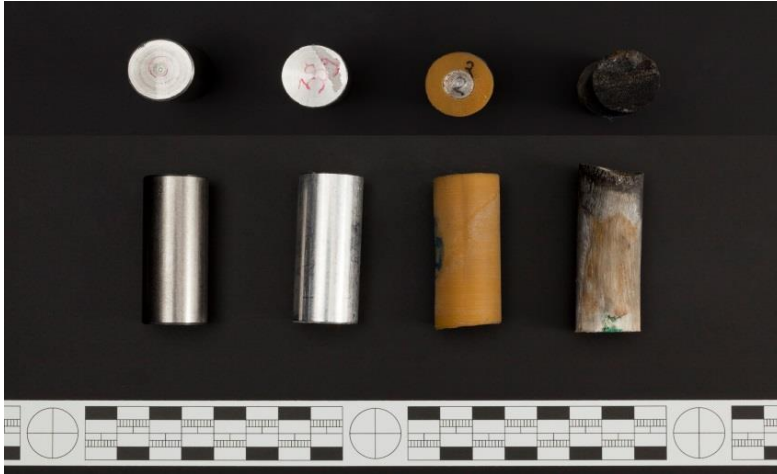
Fig. 3: Impactor heads: cylindrical steel, aluminium, polyurethane and hoof horn bars (from left to right).

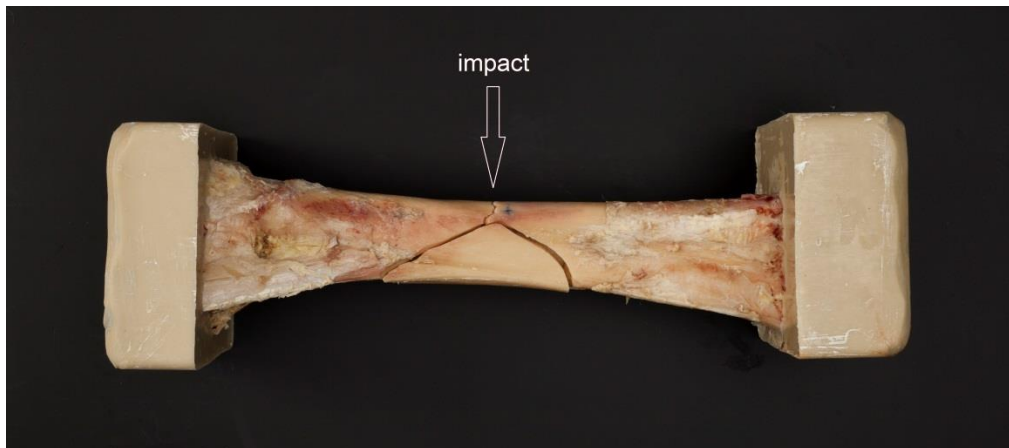
Fig. 5: Butterfly fracture of a left radius. The tip of the wedge-shaped fragment characteristically points toward the site of impact.

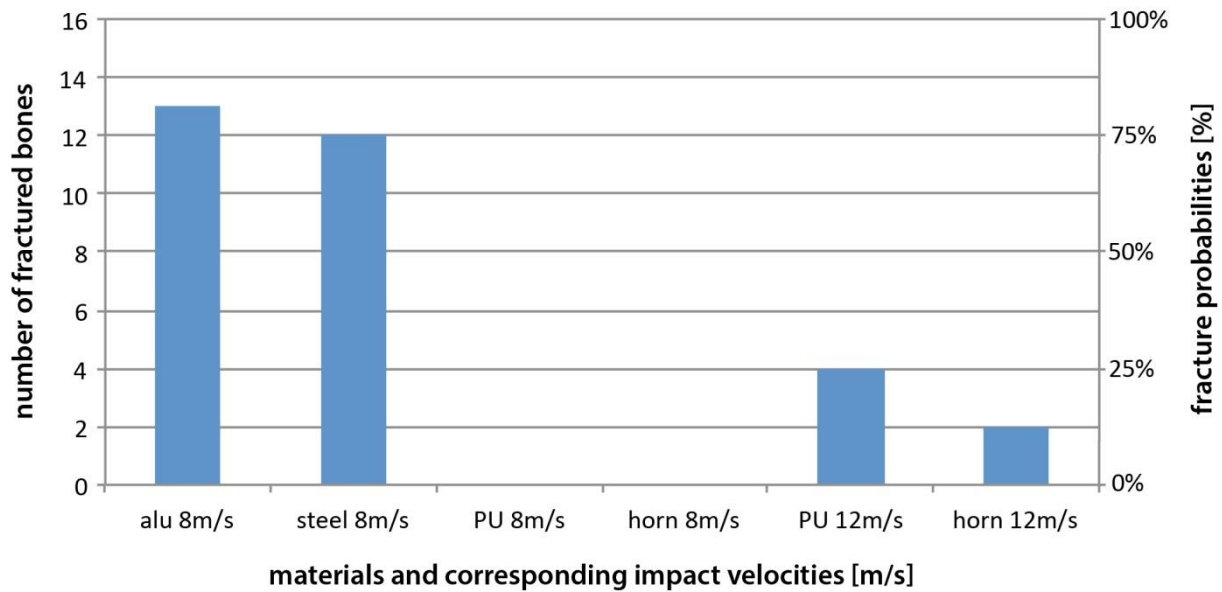
Fig. 6: Number of fractured bones and fracture probability after a simulated kick.

The fracture probabilities from all kick experiments are summarised in Figure 6, and the fracture categories are shown in supplementary Table 1. The measured true impact velocities were on average 3.3 % and 0.84 % below the nominal values of 8 m/s and 12 m/s, respectively. Nevertheless, the comparisons between the materials are not influenced by these small and material independent deviations.

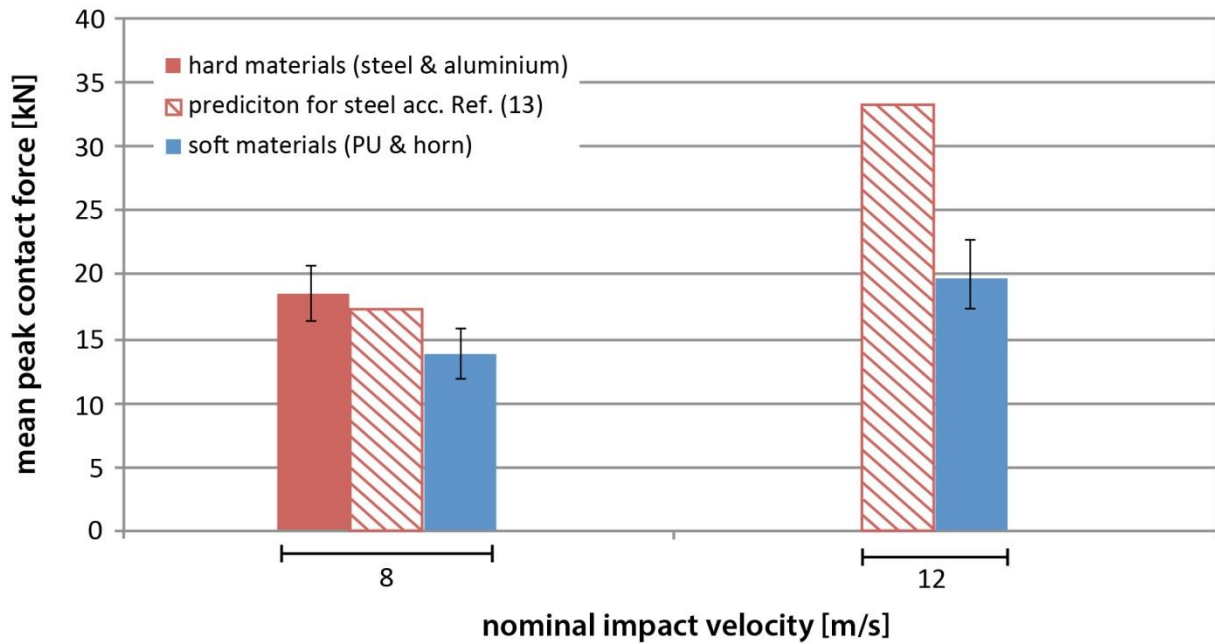
Fig. 7: Peak contact forces (F_{peak}) in case of no damage at nominal impact velocity $v_i = 8$ m/s and 12 m/s. The predicted values for steel have been calculated as $F_{\text{peak}} \approx 0.926 \cdot v_i^{1.45}$ (13) for the actual average impact velocities 7.73 m/s and 11.90 m/s.

F_{peak} of hard materials was significantly larger than that of PU and hoof horn ($p < 0.001$; Tables 2 and 3). The peak contact force on the tibia was an average of 11% higher than that of the radius ($p = 0.014$; Table 3). The average peak contact forces and the predicted values based on the empirical function for a steel impactor head as calculated previously (13) are shown in Figure 7. The peak contact forces of hard materials matched the fit calculated previously (13) ($F_{peak} \approx 0.926 \cdot v_i^{1.45}$; (13)) whereas the peak contact forces of soft materials were 25 % lower. At an impact velocity of 12 m/s, the soft materials had F_{peak} values similar to those of hard materials at 8 m/s (Figure 7).
