Conference or Workshop Item

Huggel, Christian (2005). Impacts from climate change related hazards in high-mountain areas: a review of assessment techniques. In: First International Conference on the Impact of Climate Change on High-Mountain Systems, Bogota, 21 November 2005 - 23 November 2005, 109-121.

Impacts from climate change related hazards in high-mountain areas: A review of assessment techniques

Christian Huggel¹

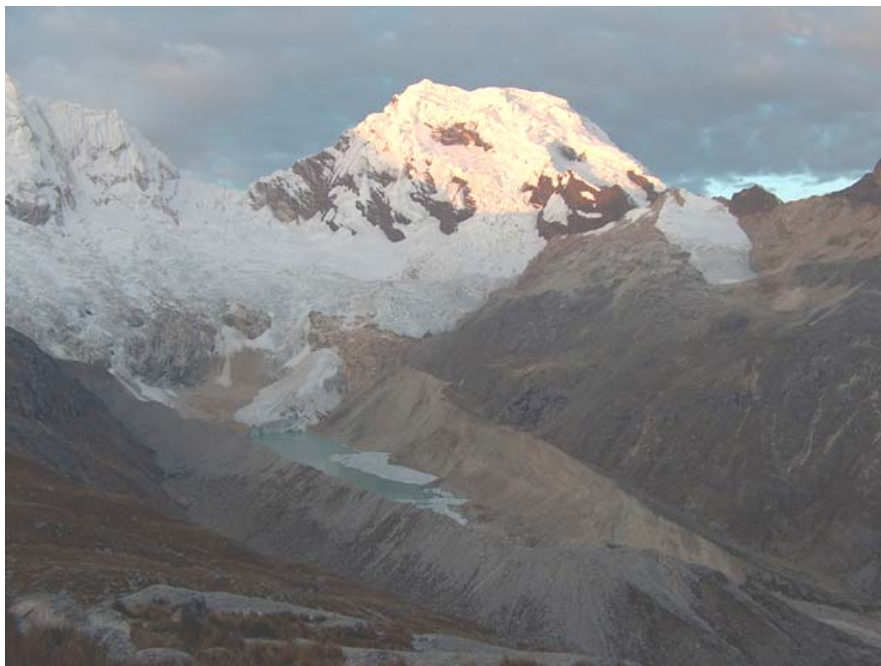
Figure 1. The glacial lake Palcacocha in the Cordillera Blanca, Perú, dammed by a massive moraine bastion. The moraine breach from the 1941 lake outburst is to the lower right. In the background Pucaranra mountain (6.156 m.a.s.l.) (photo: E. Hegglin, 2005).

by a low probability of occurrence but high potential magnitude as is typical for glacial hazards (Huggel *et al.*, 2004a). Due to constant glacier retreat, Lake Palcacocha has regained size in recent years and now is filled with 3,7 million m³ of water. A recent incident at Palcacocha caused deep concern and confusion in the 100.000+ people of Huaráz. In March 2003, one of the steep moraine slopes confining the lake failed and generated an impact wave in the lake. The wave destroyed one of the constructed overflow dams and generated a small flood. Huaráz was affected by an increased sediment load in the river causing severe fresh water problems for one week. A concurrent NASA report was released regarding the threat of an ice avalanche falling into Lake Palcacocha thereby producing an outburst flood which could badly affect Huaráz (Steitz and Buis, 2003). This provoked great worry and even panic among people in Huaráz, and eventually considerable economic loss. The NASA report turned out to be a severe misinterpretation (Vilimek *et al.*, 2005) but the incident demonstrated the vulnerability of the region not only to natural disasters but also to failed risk communication (Huggel *et al.*, 2007).

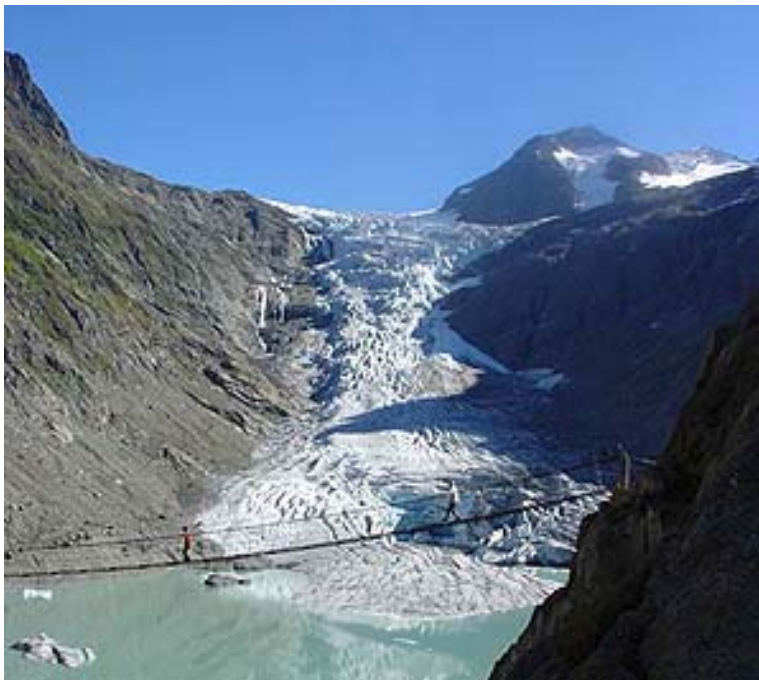
Figure 2. The rapidly retreating tongue of Trift glacier in the Swiss Alps with the growing lake which represents a potential danger for the downstream areas. A hanging bridge had to be built because the traditional alpine route is no longer accessible due to lake formation (photo: KWO, 2005).

conditions (i.e. mainly the bedrock barrier) make the possibility of full and sudden lake failure unlikely but downstream structures could nevertheless be seriously affected by smaller potential floods. In addition to the growing hazards, the glacier retreat and lake formation made the track to a frequently visited alpine hut inaccessible and a hanging bridge had to be built instead (figure 2).

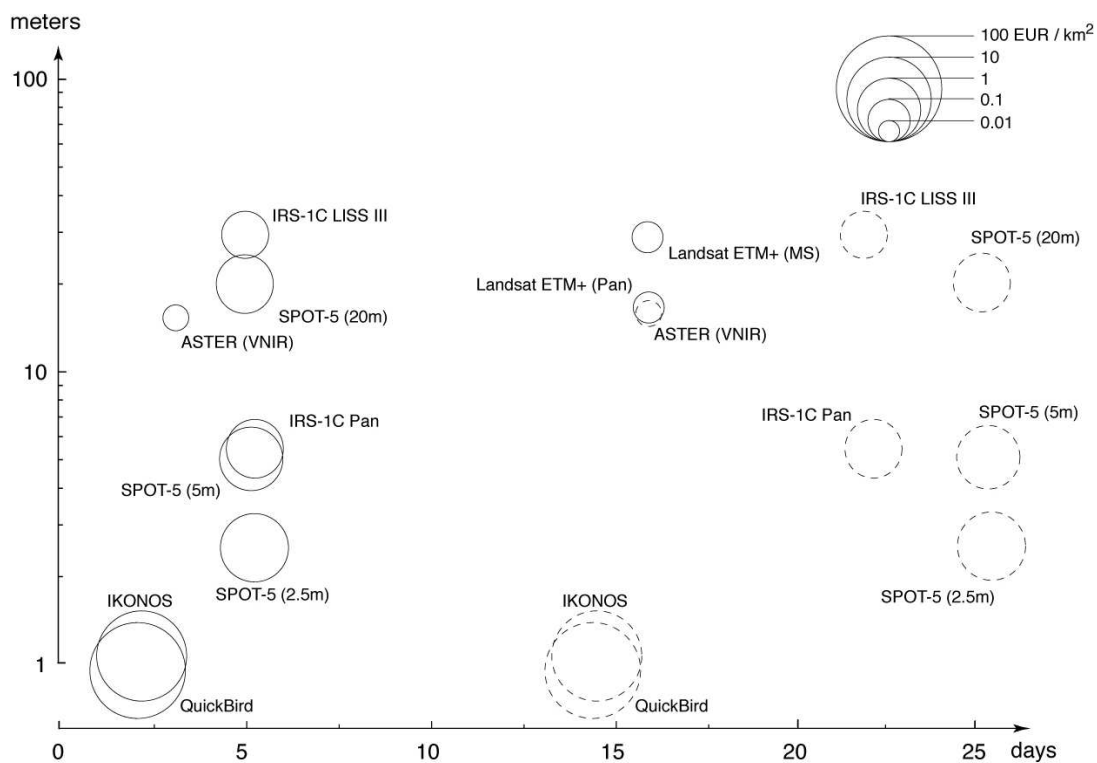
Figure 4. Overview of available optical satellite sensors for use in monitoring of mountain areas in terms of revisit periods (dashed circles indicate regular revisit cycles, solid circles refer to special sensor programming requests), spatial resolution and acquisition cost (may be subject to changes) (data partly from Kramer, 2002).

The rapid changes in glacierized high-mountain regions induced by climatic change makes regular observations a critical prerequisite for early detection of possibly hazardous processes. Most high-mountain areas are remote, physically difficult to access and sometimes involved in political and military conflicts such as in the Caucasus or in the Kashmir region. Remote sensing based techniques therefore represent important tools for monitoring in such areas. Satellite sensors have experienced a rapid technical development in the last decades and currently provide information at spatially and temporally high resolution. High cost effectiveness in comparison to on-site studies are a further strong advantage. Figure 4 provides an overview of currently important optical satellite sensors with their spatial resolution in relation to their temporal resolution and cost of acquisition.
